Project Profile

Hunt Corporate Headquarters
— Fountain Installation
Dallas, Texas

Sika Sarnafil Waterproofing System Keeps Water Feature Watertight

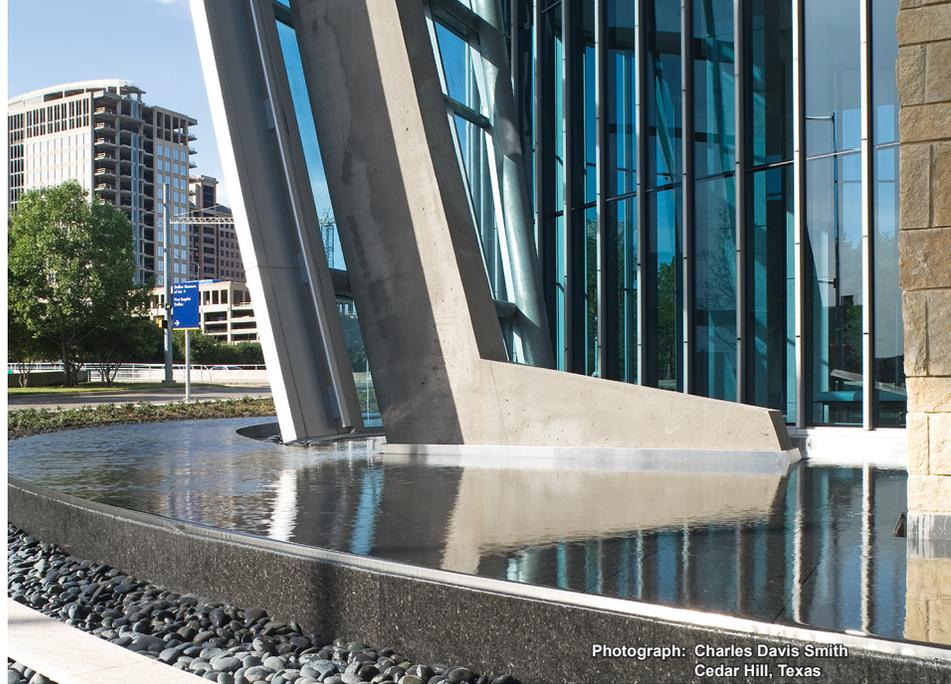
The Hunt building in downtown Dallas incorporates an exterior and interior fountain that wraps around the front of the building and has many attractive features which include a fountain, waterfalls, ponds, and underwater lighting.
